CONTINUING ELIGIBILITY INSPECTION (CEI) REPORT
FOR FLOOD CONTROL PROJECTS

1. Project Name: KK Dam Flood Control Project

2. Date of Inspection: January 14, 2003

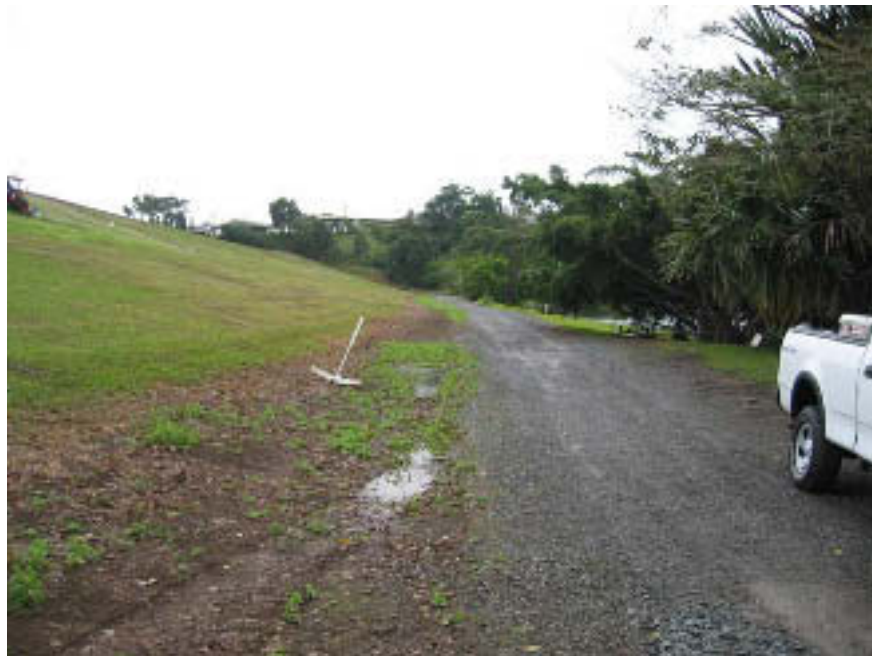
Overview of intake tower maintenance road. Do not remove trees on right side of picture adjacent dam and reservoir. A study was done by the Corps, which documented that the trees would not undermine the integrity of the dam.

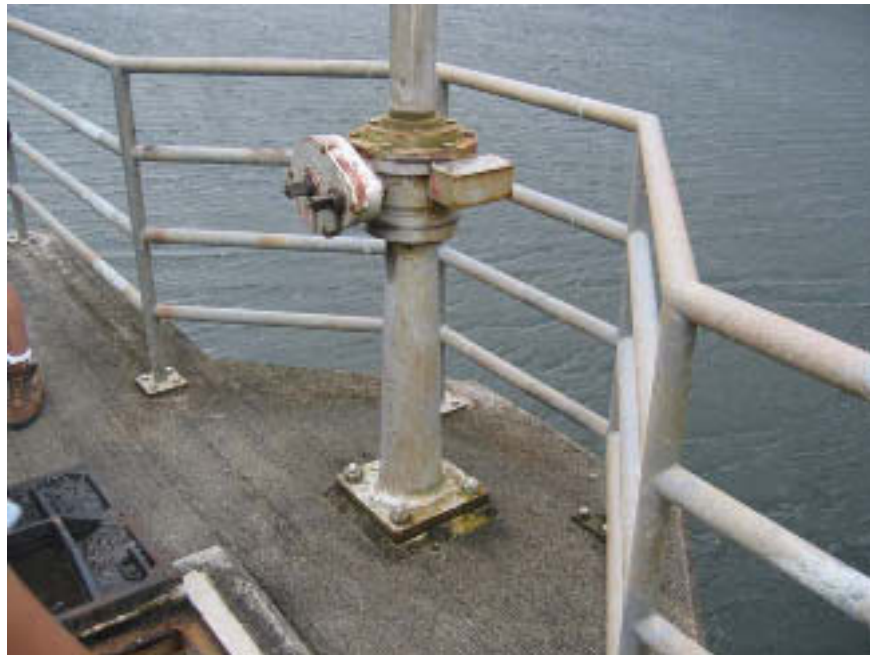
View of stem and crank shaft to sluice gate. Maintenance personnel said the crank to open and close the sluice gate has become more difficult in recent years even after mechanical connections were oiled down. They aren't sure what the problem is. Elodea Densa might be part of the problem as the reservoir has been plagued by the infestation of this sea plant used in aquariums; Elodea Densa and other debris might be sandwiched between the sluice gate and frame.

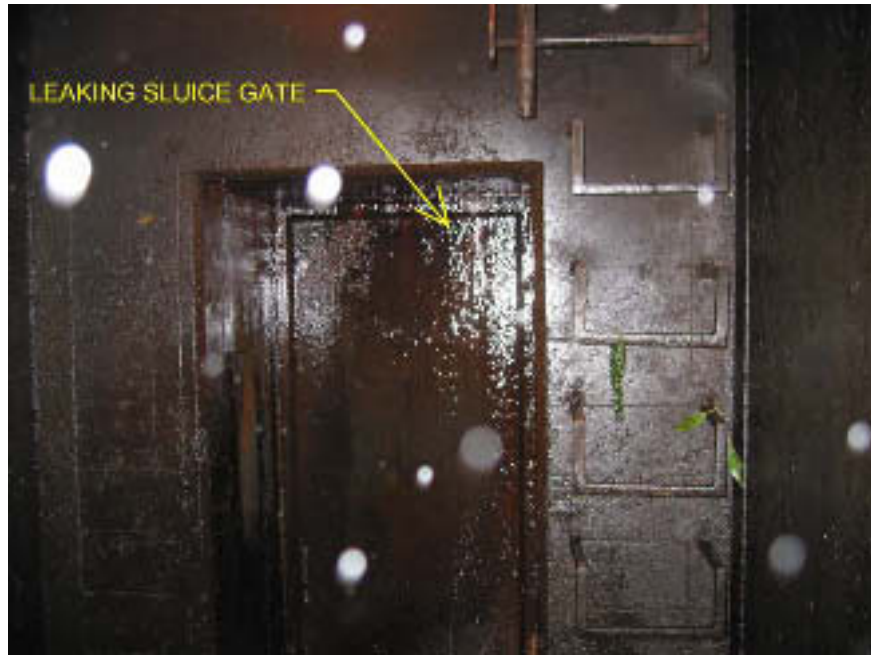
Continue to monitor leak in sluice gate at bottom of intake tower entrance shaft. Elodea Densa observed hanging on ladder rungs.

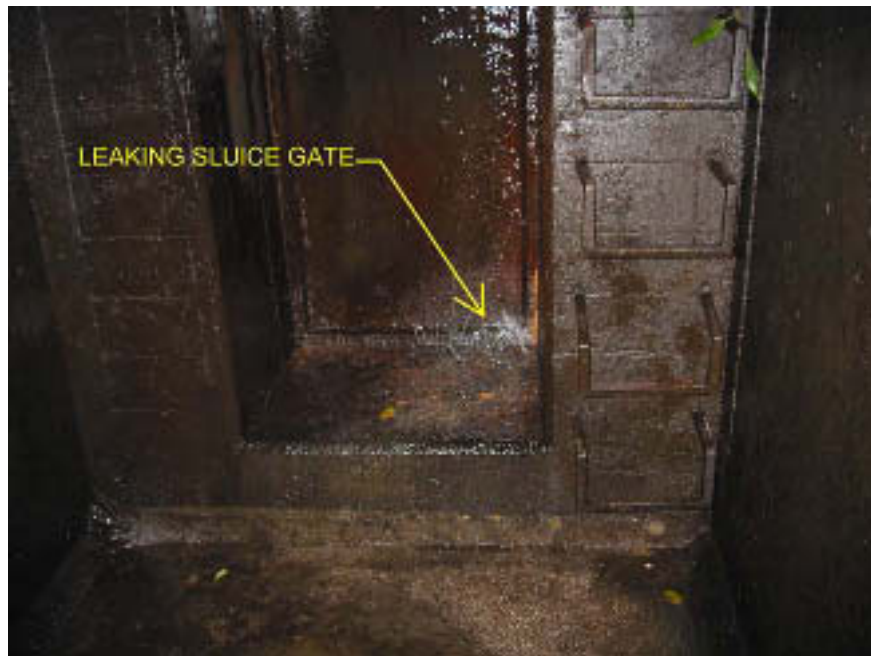
Continue to monitor leak at sluice gate bottom corner.

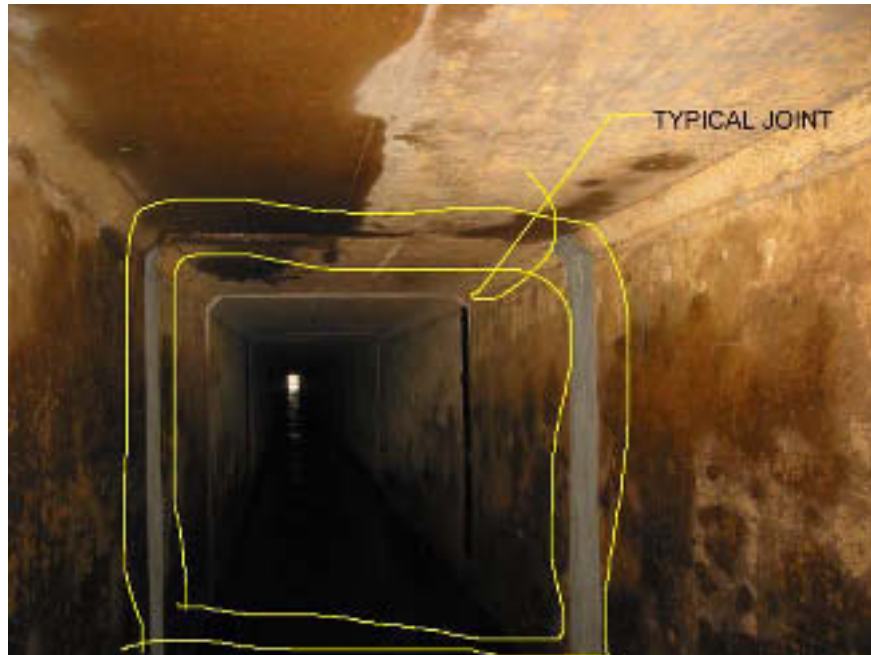
All 27 joints showed some form of concrete patching (typical).

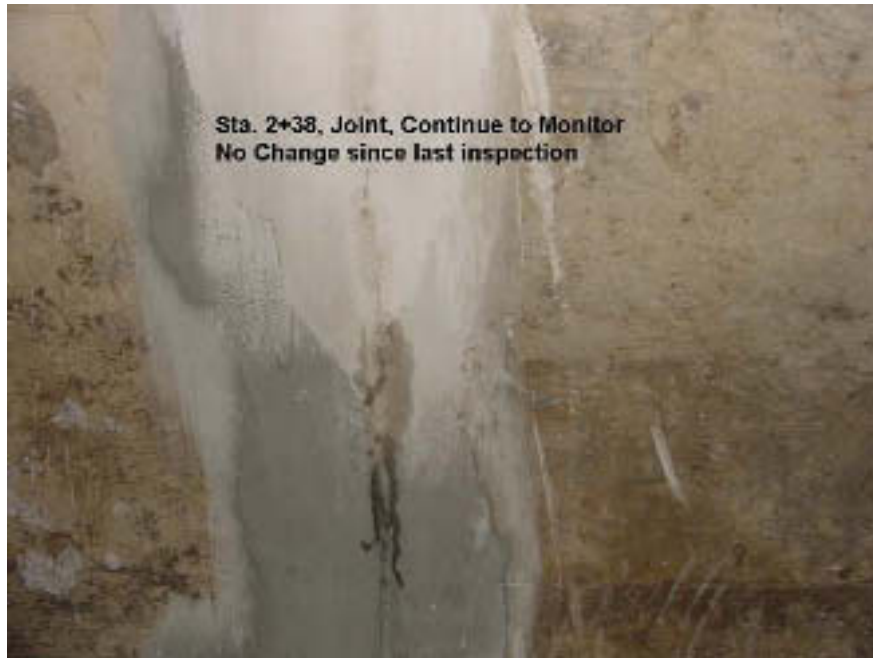
Joint #12 - Sta. 2+38, monitor patch joint (NDN).

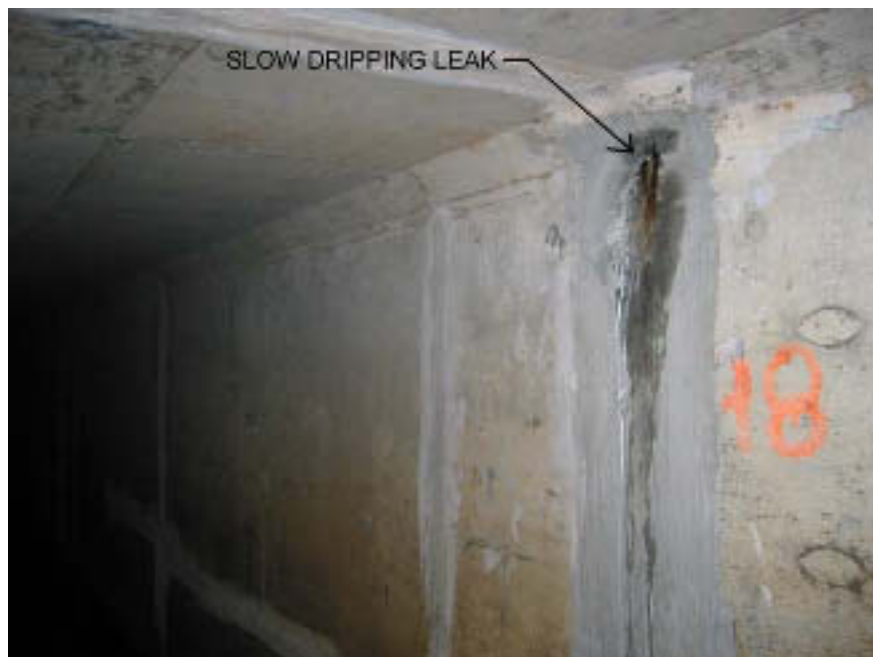
Joint #15 - Sta. 2+98, patch crack with slow dripping leak.

Location	Station	Key Comments and/or Defects
Dam - Access Road to Intake Tower		Do not remove trees adjacent access road to intake tower and reservoir.
Dam - Intake Tower/Reservoir (sluice gate stem and crank)		Maintenance is having a difficult time with opening/closing sluice gate even after key mechanical joints have been oiled. Problem unknown. Elodea Densa vegetation infestation in reservoir may be part of the sluice gate problem since debris and elodea densa become sandwiched between the sluice gate and frame. One suggestion would be to drain the reservoir to clear all the elodea and then to check on the sluice gate and crank to find the exact problem.
Dam - Intake Tower (sluice gate)		Monitor leak at sluice gate bottom right hand corner.
Dam - Intake Tower (joint)	2+38	Monitor patched joint #12.
Dam - Intake Tower (joint)	2+78	Monitor hairline crack for leaking in the future.
Dam - Intake Tower (joint)	2+98	Slow dripping crack needs to be patched.

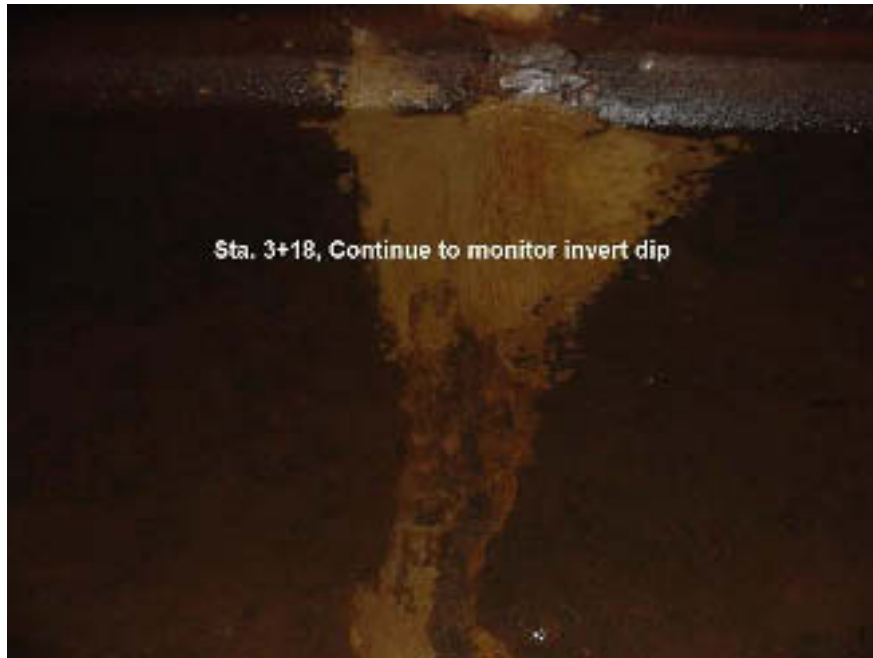
Dam - Intake Tower (joint)	3+18	Monitor invert dip causing 0.5" deep ponding water. Dip is probably caused from settling due to the weight of the dam above.
Dam - Spillway (testing of weep holes)	(-)1+00 to 10+00	For the next annual inspection, use water tank to test ground weep holes for proper drainage of French drains under spillway invert.
Dam - Spillway (left wall)	(-)1+15	Located upstream of Ogee weir. Monitor cracking at left wall below drain pipe.
Dam - Spillway (left wall)	(-)1+30	Remove vegetation from joint.
Dam - Spillway (right wall)	(-)1+30	Monitor cracking above and below drain pipe.
Dam - Spillway (right wall)	(-)0+70	Monitor seepage through crack in wall. Currently seepage in structure is causing rusting in the rebar.
Dam - Spillway (right wall)	(-)0+60	Monitor seepage in cracked area.
Dam - Spillway (left wall)	3+00 and 4+00	Remove trees, roots, and branches adjacent to wall.
Dam - Crest	6+00, 7+50, 13+25	Fill depressions/holes with basecourse. Holes caused by maintenance vehicles.

Joint #16 - Sta. 3+18, Monitor invert (dip with ponding water)

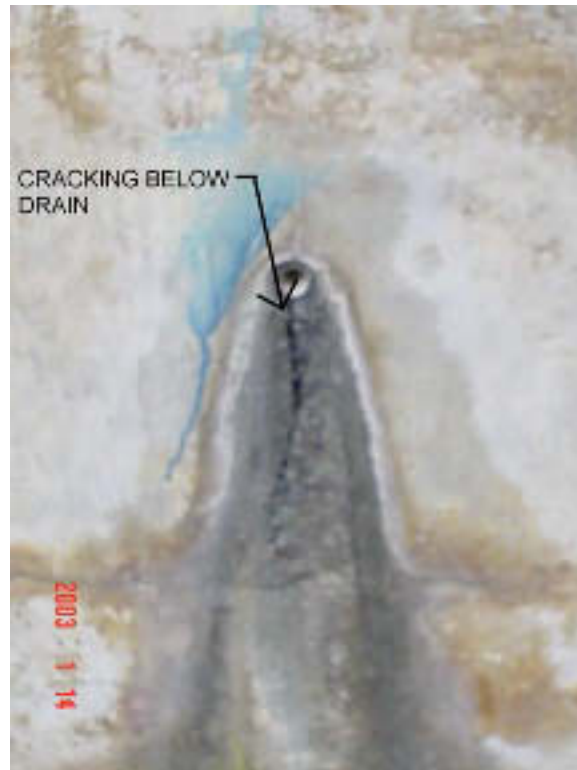
Sta. (-)1+15, Right Wall, Monitor cracking below drain.

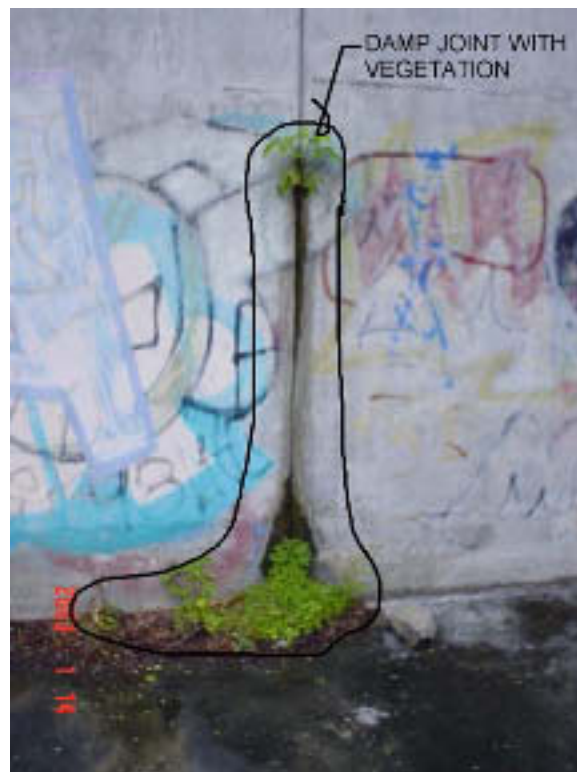
Sta. (-)1+30, Left Wall, Remove vegetation from joint.

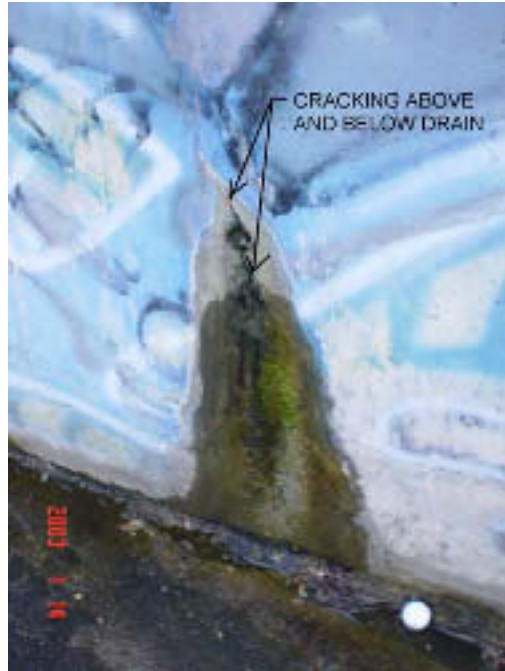
Sta. (-)1+30, Right Wall, Monitor cracking above and below drain.

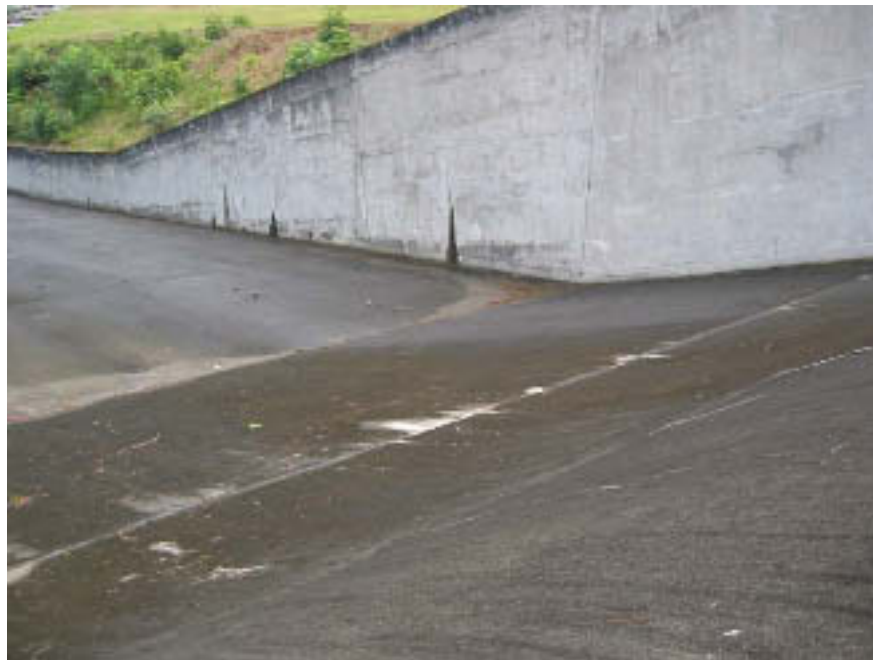
Sta. (-)1+00, Right Wall, view of seepage and cracking through spillway channel.

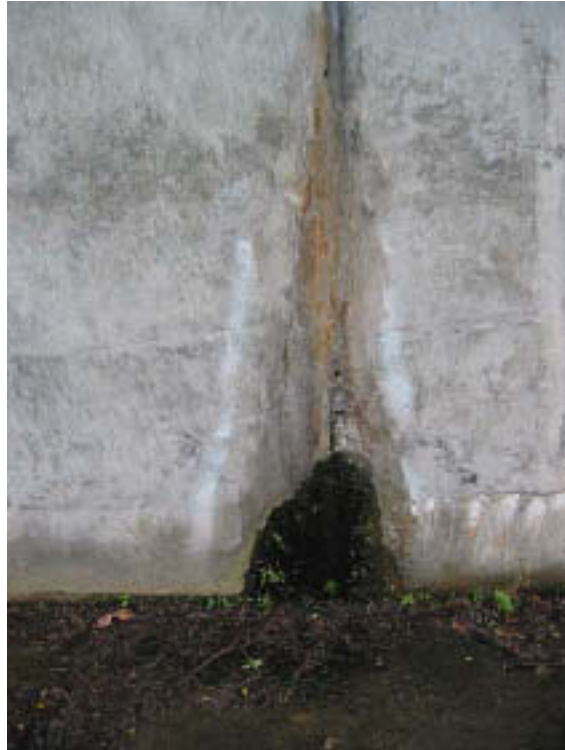
Sta. (-)0+70, Right Wall, Monitor seepage through wall. Monitor area.

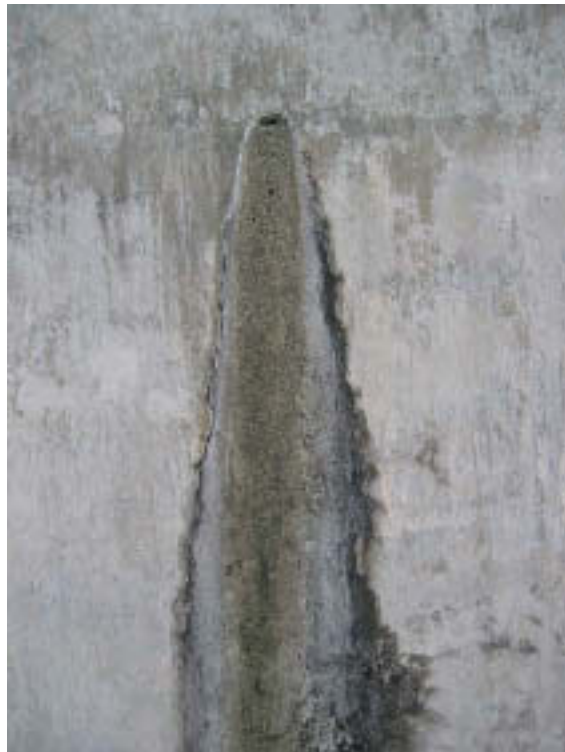
Sta. (-)0+60, Right Wall, Monitor seepage through wall.

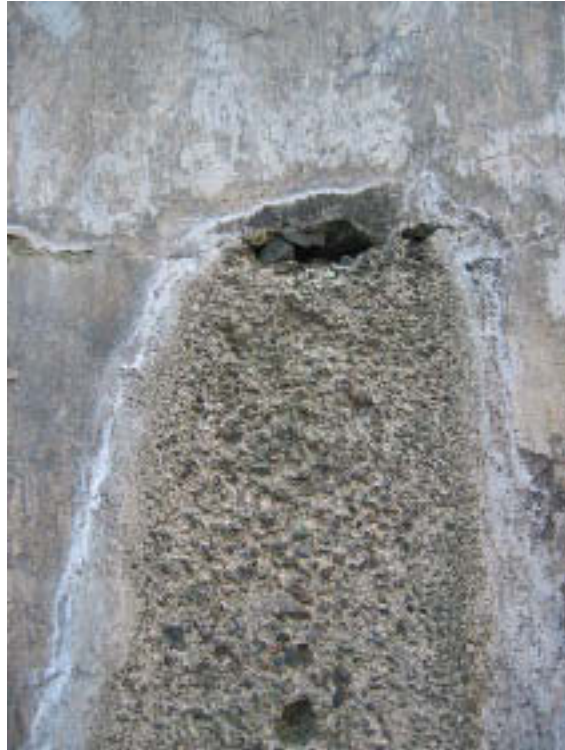
Sta. (-)0+60, Right Wall, Close up of cracked void.

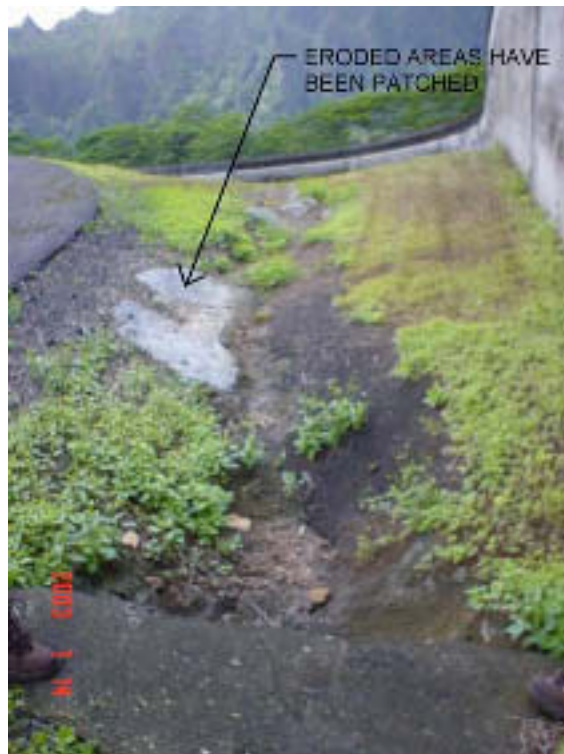
Sta. (-)0+70, Right Wall, eroded areas have been patch for slope leading to approach channel. Corrected deficiency from last year.

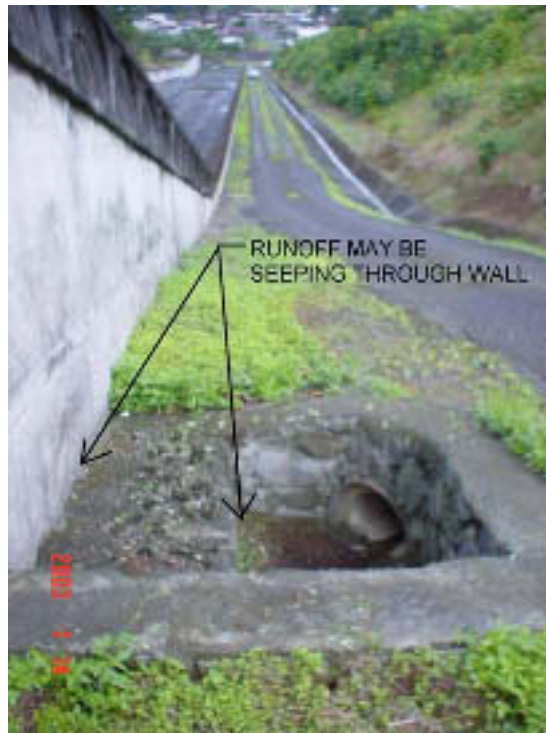
Sta. (-)0+60, Right Wall, Runoff entering drain area is contributing to seepage through wall. Continue to monitor.

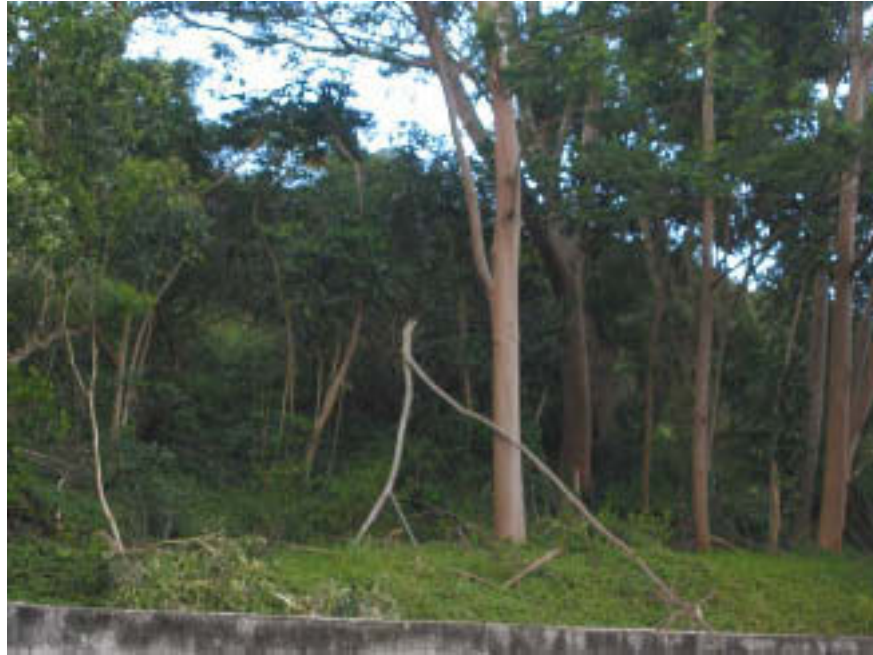
Sta. 3+00, Left Wall, again continue to remove trees and branches adjacent to structure (typical).

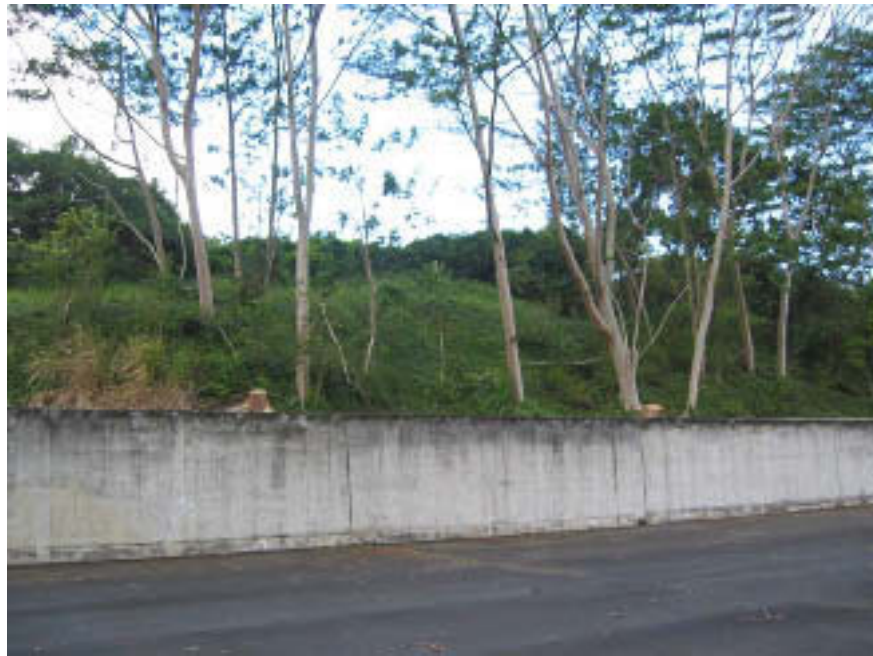
Sta. 4+00, Left Wall, Continue to remove trees adjacent to spillway wall. Trees roots adjacent to wall will damage structure (typical).

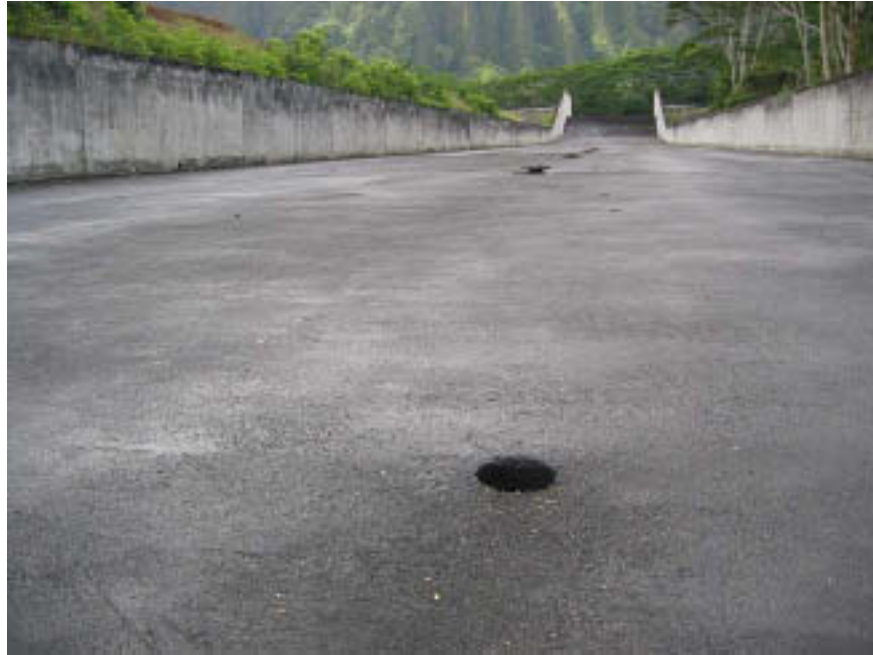
Sta. 5+00, Channel Invert, Continue to monitor and cleanout weep holes as required.

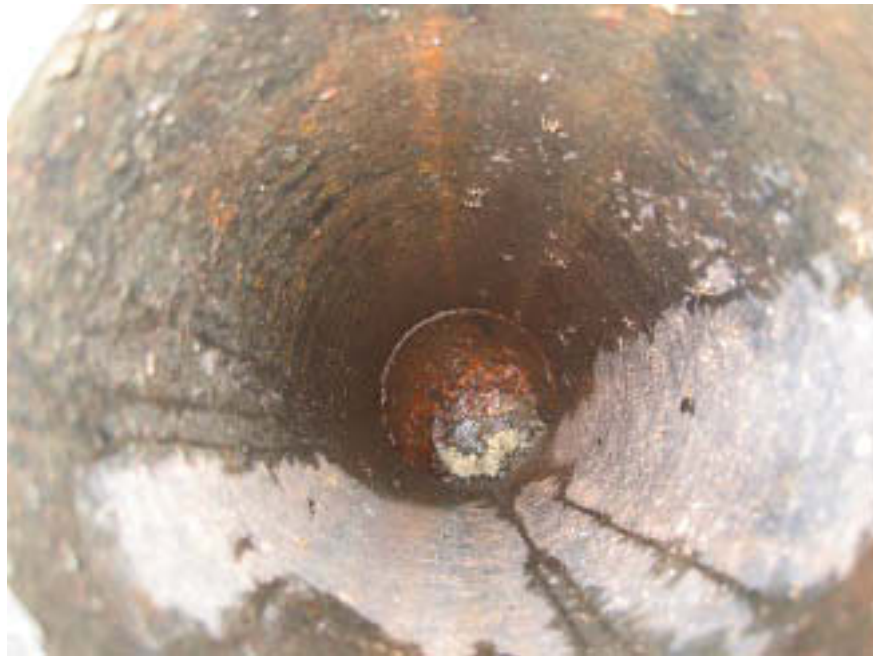
Sta. 5+50, Typical weep hole to French drain. Continue to clean out as required.

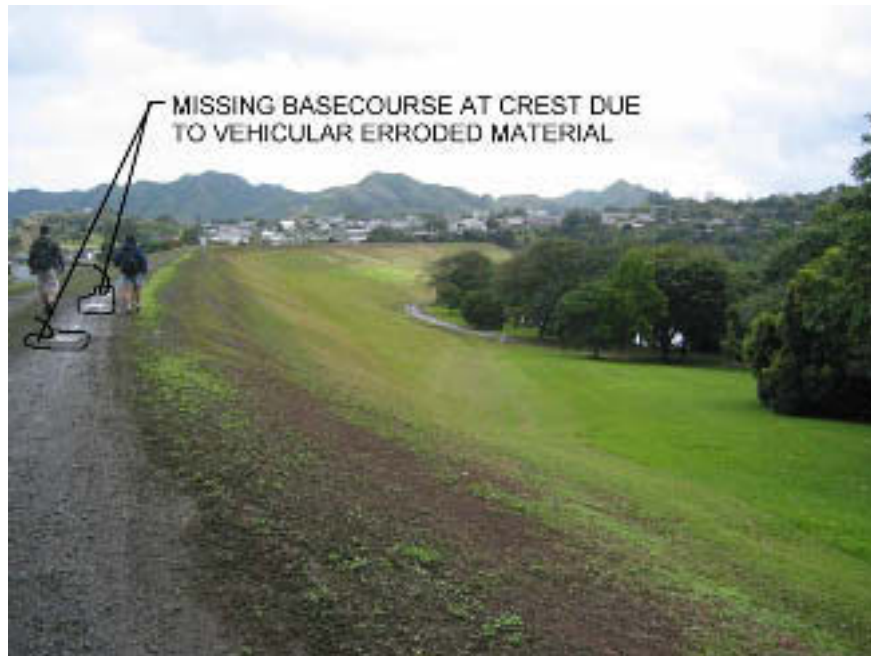
Sta. 6+00, Overview of dam crest, reservoir side - Add basecourse to eroded crest spots due to maintenance vehicular access.

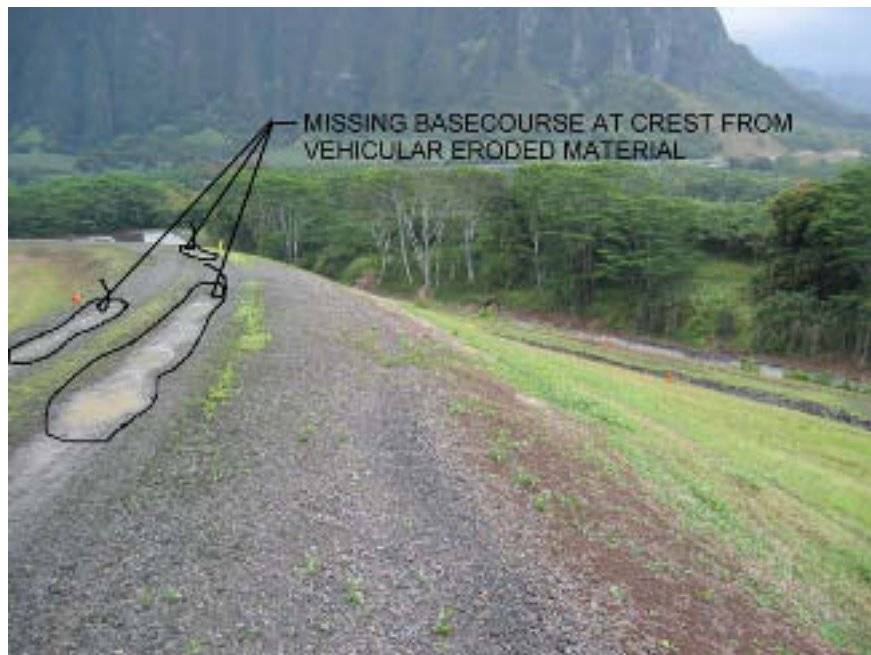
Sta. 7+50, Overview of dam crest, town side - Add basecourse to eroded crest spots due to maintenance vehicular access.

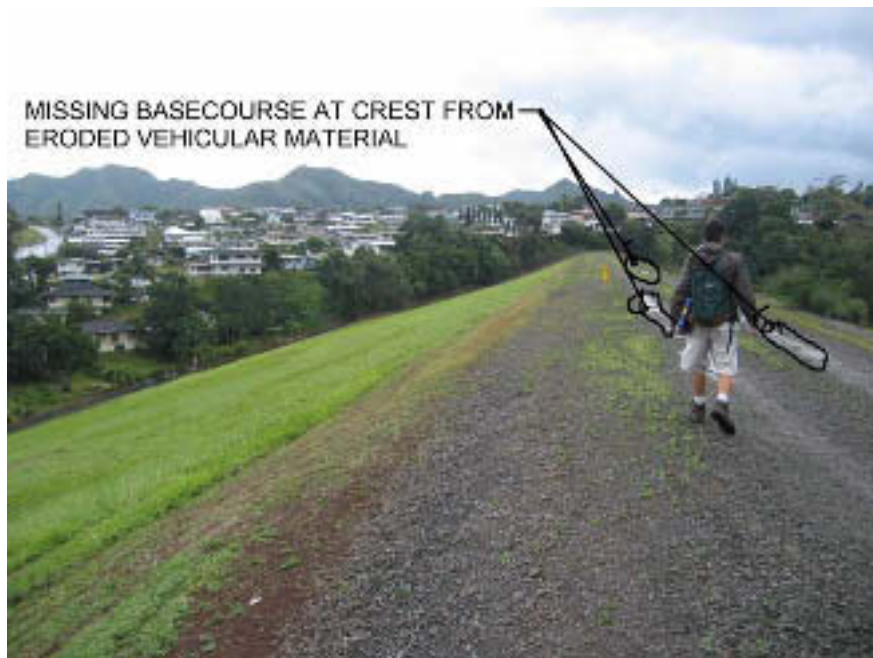
Sta. 13+25, Crest of dam with town side on left. Add basecourse to eroded spots on dam crest due to maintenance vehicular use.

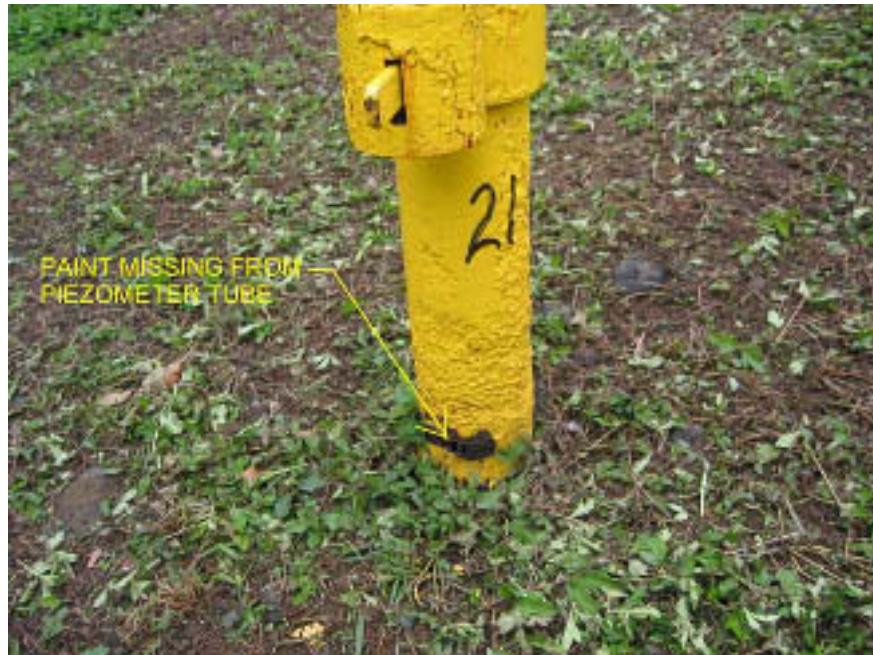
Enlarged photo of missing paint on piezometer tube #21.

Paint chipped off portion of piezometer tube #21 and remove debris from surrounding culvert used for town side interior drainage.

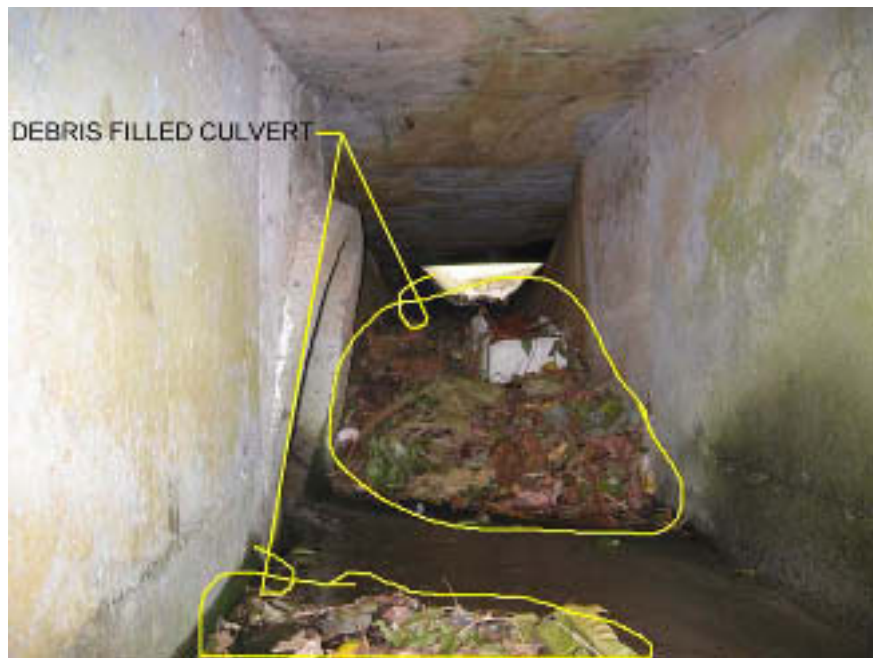
Remove vegetation and debris inside of culvert.

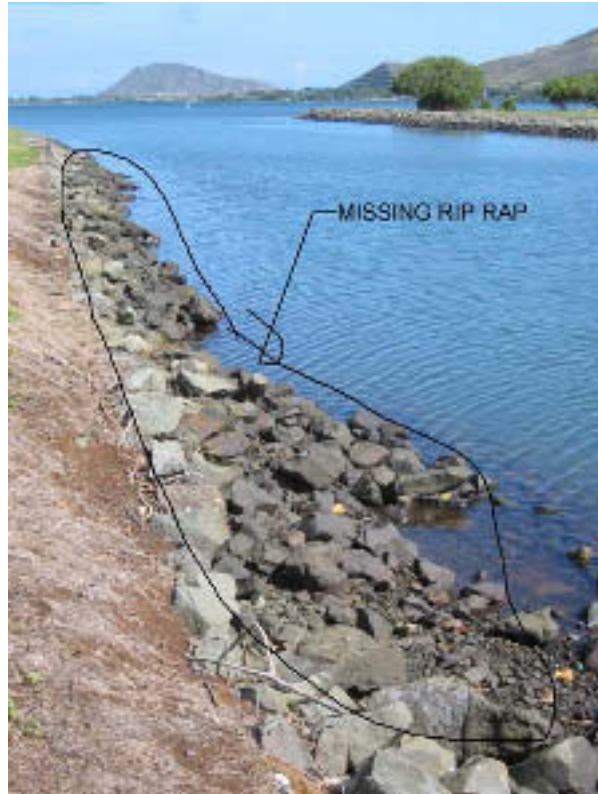
Sta. 3+00, LB, Add larger rip rap to eroded area.

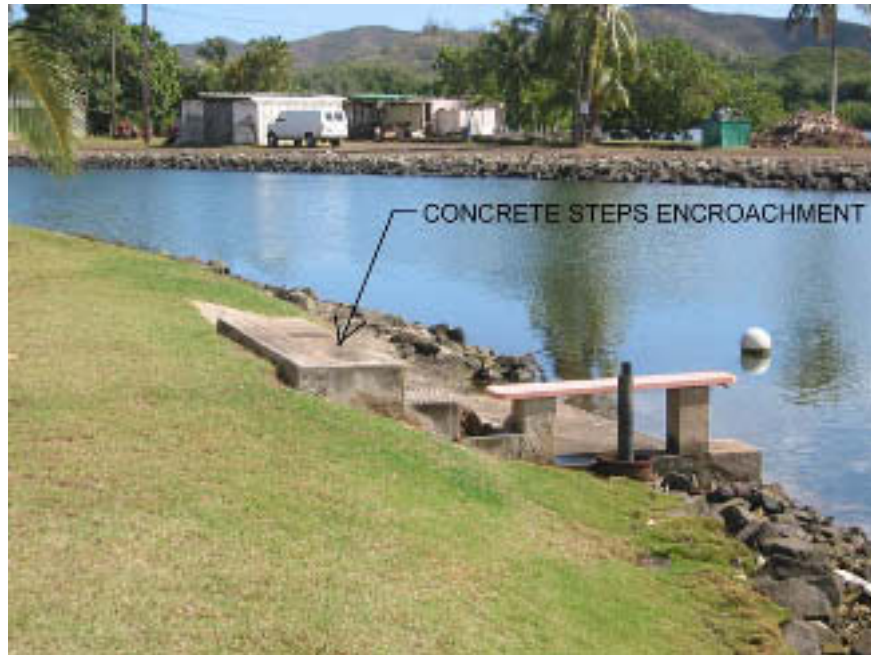
Sta. 6+00, LB, remove concrete step encroachment.

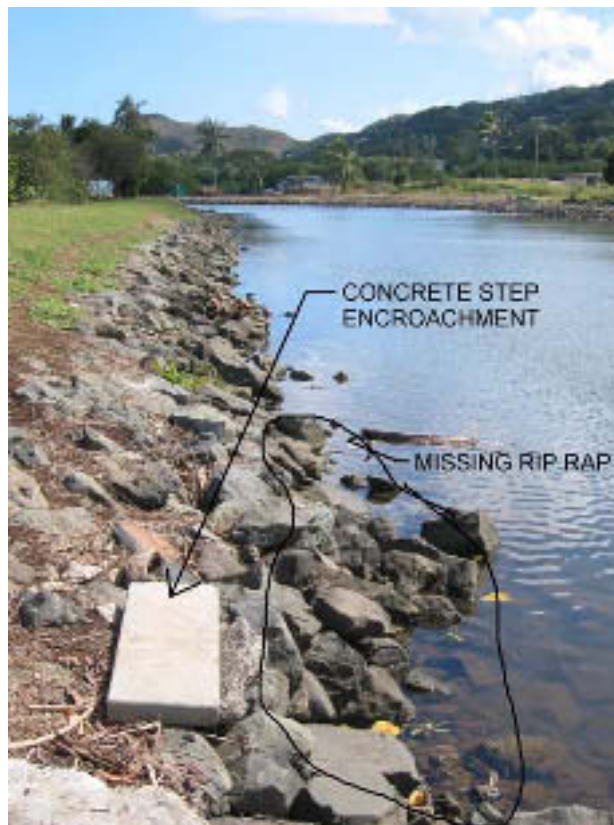
Sta. 6+25, LB, remove concrete step encroachment and add larger rip rap to eroded area.

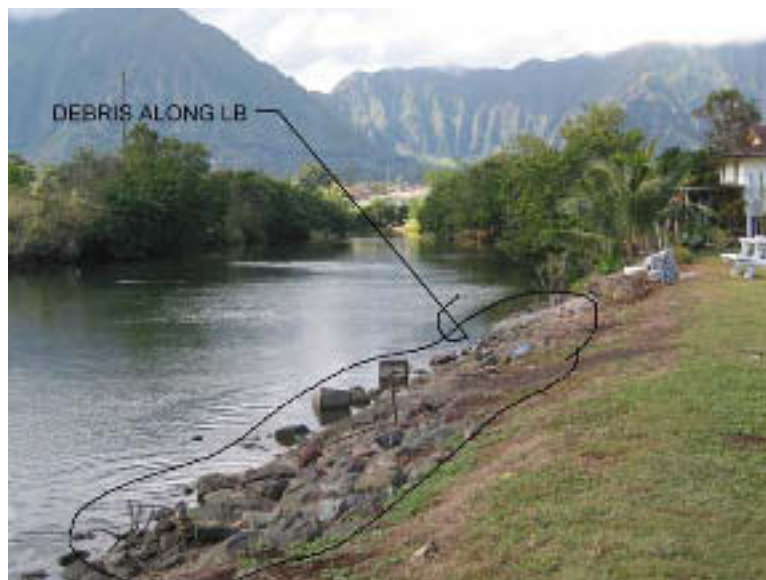
Sta. 12+00, LB, remove debris from bank. Do not remove rip rap. Add rip rap to eroded areas - typical along left bank.

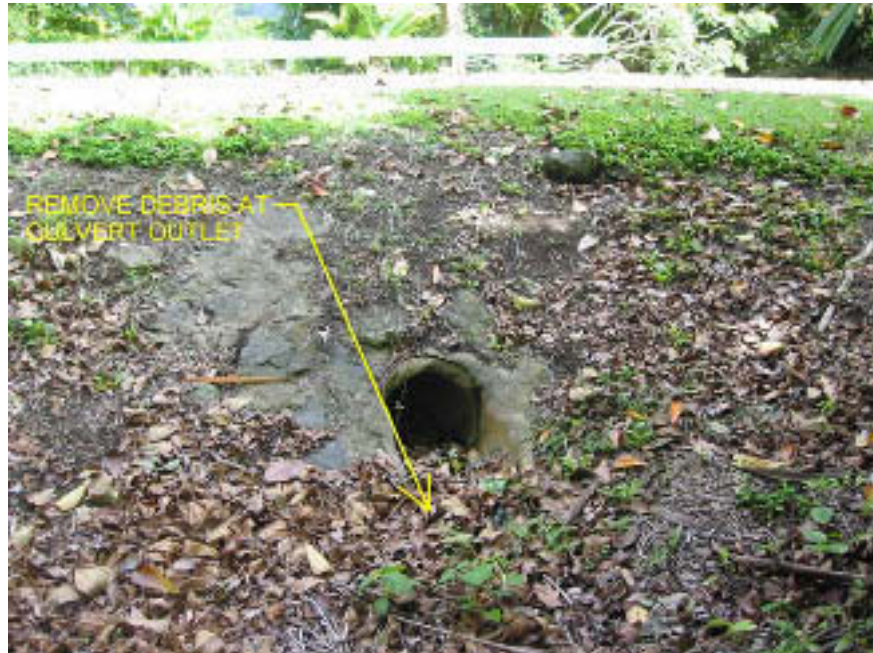
Overview of 4th culvert from park entrance relatively clear.
Remove debris around culvert outlet.

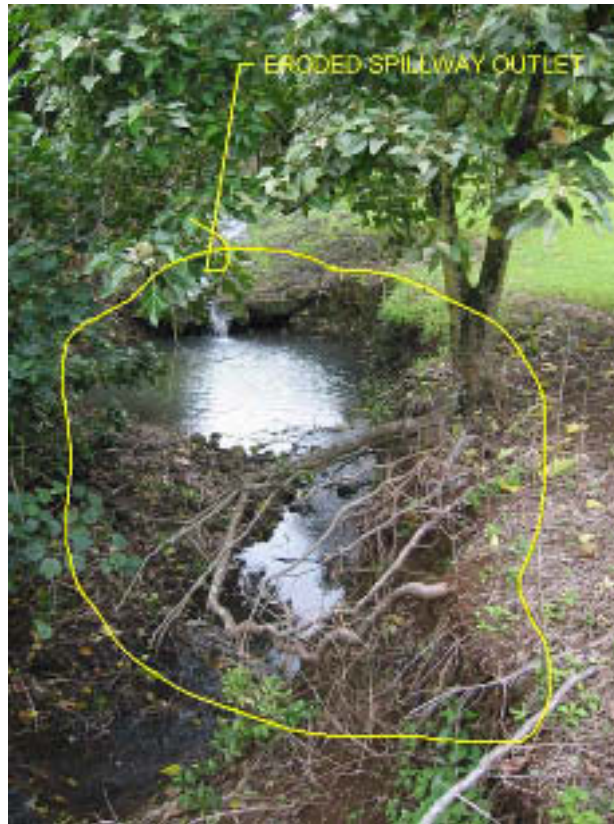
Monitor eroded spillway outlet area. Re-grade to stabilize bank and outlet as required. Remove circled tree and roots.

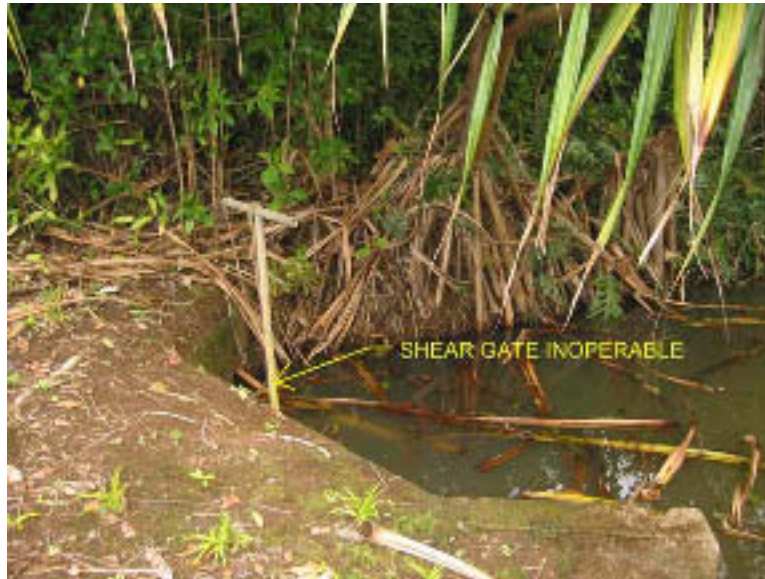
Wildlife pond gate doesn't appear to be operational or is difficult to maneuver. Check on gate.

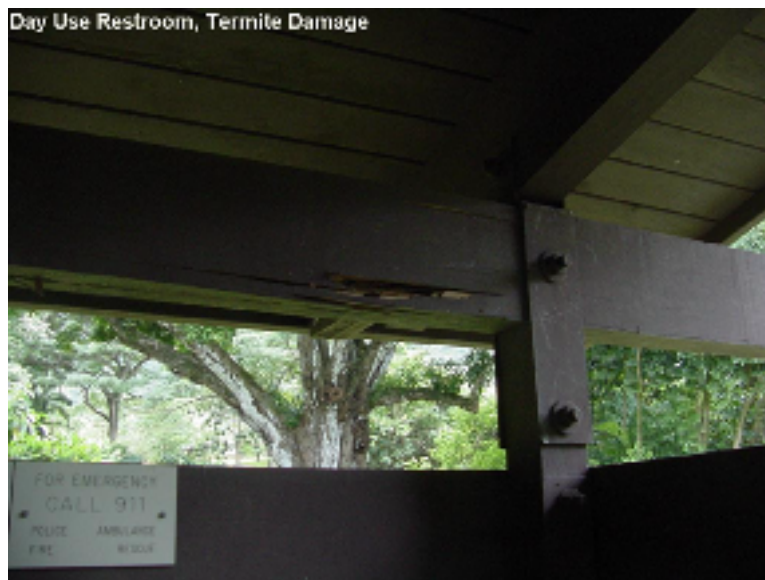
Perform structural repairs to "Day Use" restroom. Termites have damaged roof structure, brace & support beams and rafters. Same comment from last year. Work order currently being processed to do this.

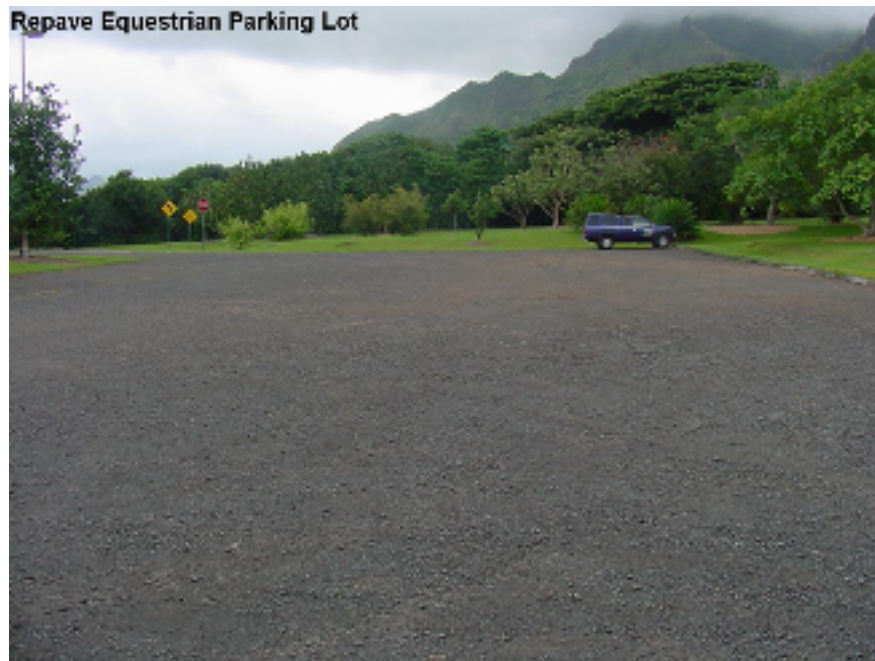
Repave the Equestrian Area parking lot. Same comment as last year. Area currently under construction for new comfort station.

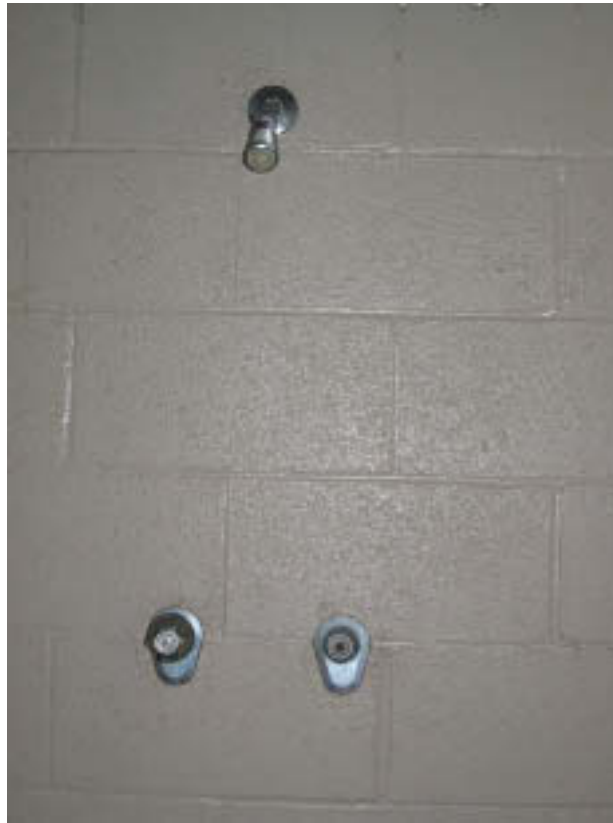
Replace Kahua Kukui missing cold water handle in the wahine portion of the comfort station.
